Washington State Parks Kopachuck State Park **Northern Loop Trail** Feb 5, 2014

Washington State Parks Kopachuck State Park Interpretive Trail Feb 5, 2014

Washington State Parks Kopachuck State Park **Beach Access Trail** Feb 5, 2014

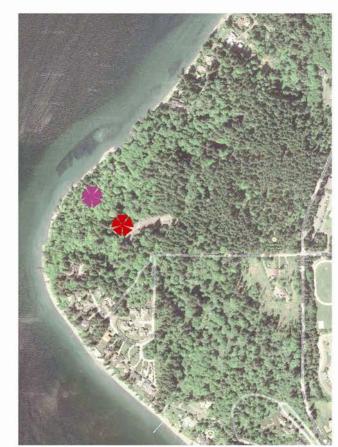
Parking Area Comfort Station

ADA Compliance Assessment: Both comfort stations have the same **ADA Deficiencies**

- Clearance around toilet shall be 60" min x 56" min.
 Grab Bars are not properly located
- 3. Toilet centerline is too close to wall. 4. Exterior approach to restroom door is too narrow.
- 5. Shower stall is not accessible.
- 6. Toilet accessories, i.e. paper towel, soap, mirrors,

do not meet ADA mounting height requirements.
