Introduction

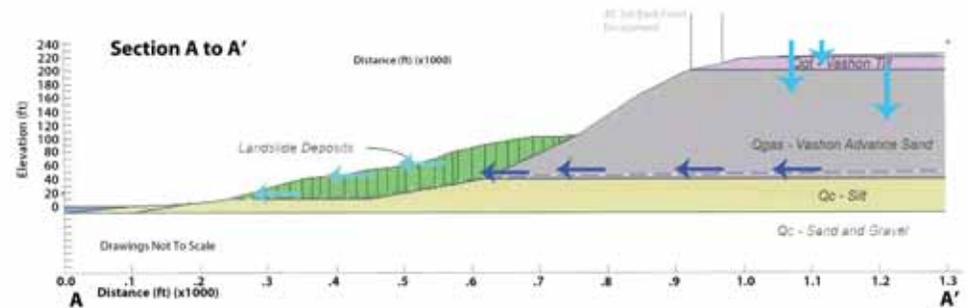
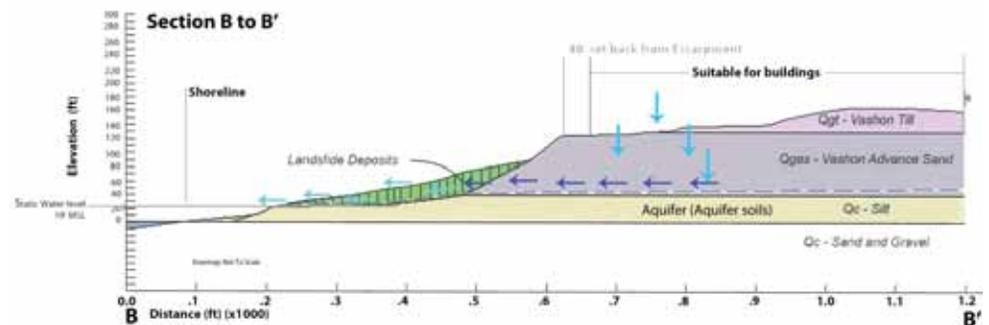
ORIGINAL GRAPHIC BY ASSOCIATED EARTH SCIENCES

deposited on the beach from above, and in turn indicated that the beach is accreting. The AES study's findings indicate that the site is undergoing a steady, incremental retreat caused by beach erosion and toe cutting. Furthermore, removal of material from the toe of the site with consequent reduction in lateral soil resistance is resulting in down-slope soil creep moving upward through the landslide mass to the head scarp. However, the landslide complex appears to have maintained its near current configuration for some time.

The natural wave erosion of the bank along the beach appears to be the primary factor behind the soil creep and small scale sloughing and land sliding which then move upslope from the beach. The beach erosion appears to occur predominantly as a result of extreme tide and storm events. The AES study indicates that soil creep from the bank upward to the main head scarp may take a period of decades followed by long periods of relative inactivity as vegetation reestablishes. This study states that there is a moderate likelihood of localized small to moderate-scale landslide activity. Annual erosion and sloughing is also likely along steep slope areas, primarily resulting from freeze-thaw action, direct runoff erosion, and natural weathering processes.

A minimum of a 40' building setback from the top of the head scarp is recommended by AES in order to provide a suitable buffer to protect future structures and associated improvements. AES recommended that mitigation for soil creep around any structures near the beach should include structurally rigid mat foundation to reduce soil creep and differential sediment within the structures. All utility connections should be flexible in order to allow a measure of play within the lines. Cuts and fills no greater than 1' should occur within 15' of the top of the head scarp or shoreline bank. All storm water from impervious services should not discharge directly onto the steep slopes. Surface water drainage should be directed away from the slopes or tightlined to the bottom of the slope. All vegetation should remain in place to provide root support for the soil.

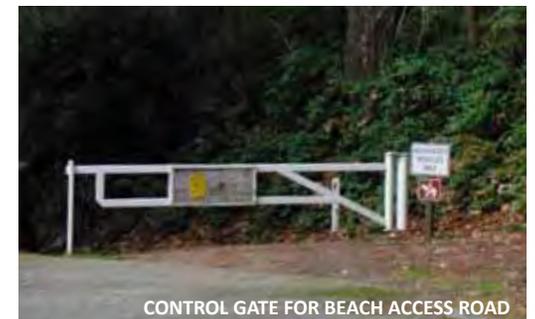
Vehicle and pedestrian access from the parking lot to the beach is via a gravel road. Access is controlled by the ranger through a manually operated and lockable gate at the north end of the main parking lot. The gravel surfacing is in relatively good condition and does not exhibit any significant erosion of the travelled surface itself. This road is used by service trucks (for beach area restroom and maintenance), park visitors (limited mostly to interpretive class leaders and car-top boat launching), and fire/sheriff vehicles. The fire department has expressed concern over the lack of a proper turnaround at the bottom of the access road.

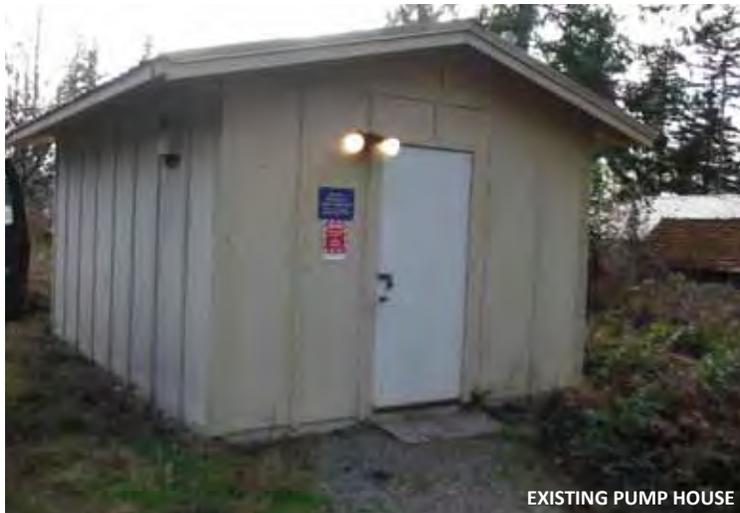
EXISTING PUMP HOUSE

The park receives domestic water supply from a single water well (constructed in 1980) located on state park property near the southwest corner of 56th Street NW and Kopachuck Drive NW. This system is a shared source facility that serves the park as well as Kopachuck Middle School and Voyager Elementary School (Peninsula School District). This system includes the well, a treatment facility, a distribution system, and a 40,000 gallon storage facility. There is an additional 70,000 gallon offsite fire flow storage and booster pump facility on school district property but this is for school protection only. The shared water system is managed by Peninsula Light Company which operates other small systems as well. The park is served by a 6" line from the storage tank which splits to serve the schools.

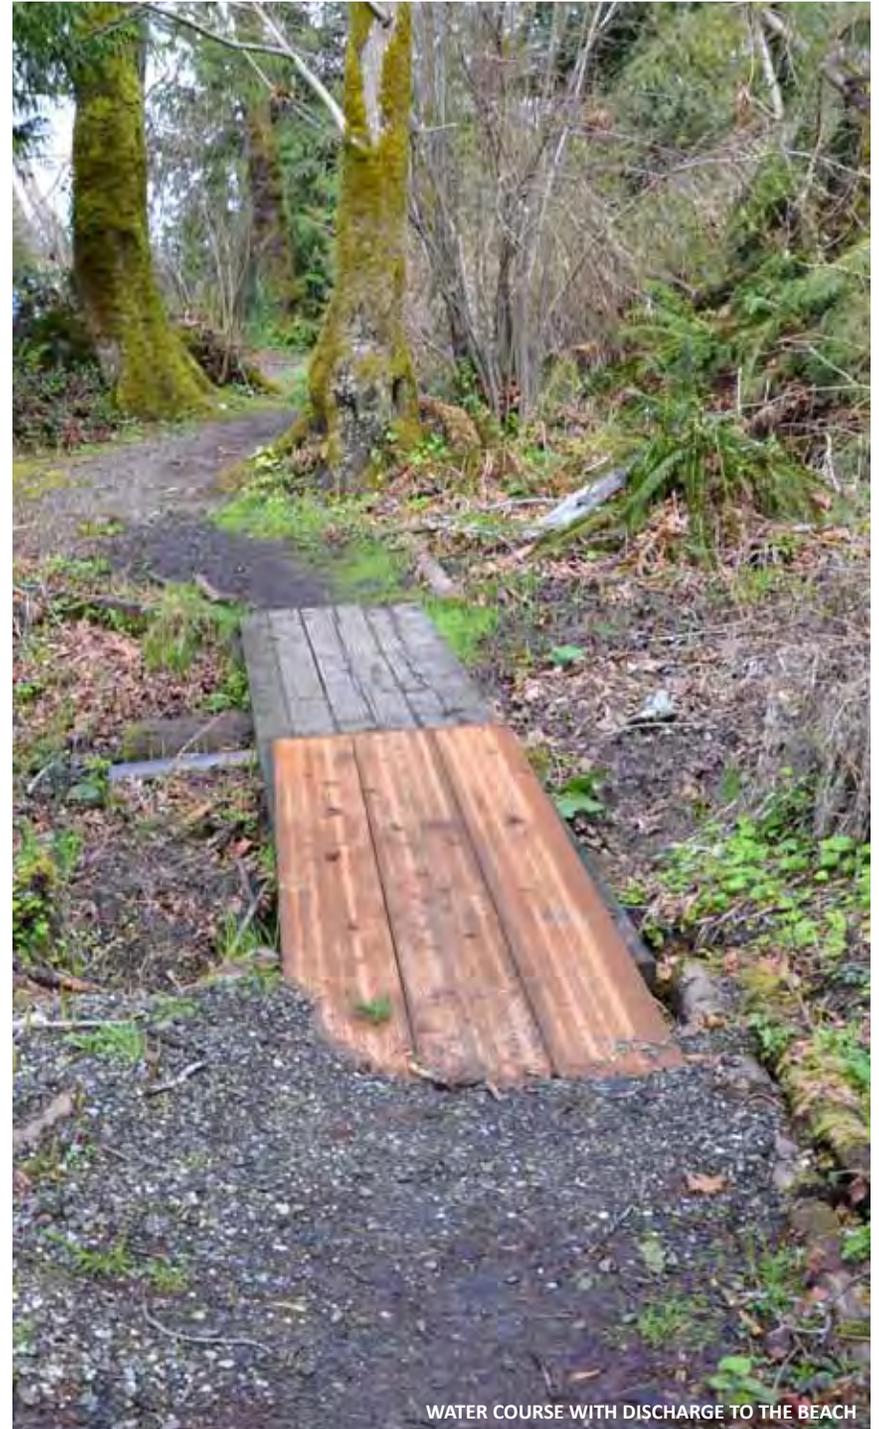
WATER COURSE WITH DISCHARGE TO THE BEACH

The park does not have a modern storm water collection conveyance or treatment system. The roadways and parking lot drain untreated to the northwest with eventual surface discharge to the beach. There is some infiltration as well as transpiration and evaporation along water courses leading to the beach. The main parking lot is paved with asphalt and is in relatively poor condition. There are obvious signs of significant pavement and asphalt curb failure and erosion problems along the west edge. The parking lot sheet flows to the northwest and drains into openings along the perimeter, channeling runoff down the receiving courses. There are two main natural receiving courses draining the parking lot, both of which eventually convert to small streams or water courses with discharge to the beach.

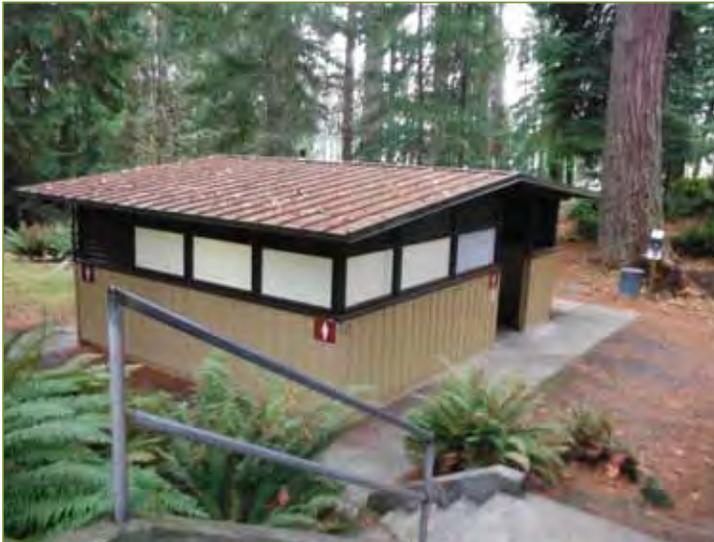
DAY USE AREA

This building, constructed in 1959, does not meet current ADA requirements. In particular, deficiencies include:

- no accessible route to the building
- significant grade differences between the restroom and parking area
- clearance around the toilet does not meet the 60" x 56" minimum
- grab bars are not properly located
- toilet centerline is too close to the side wall
- the exterior approach to the restroom door is too narrow
- toilet accessories – mirrors and soap/paper towel dispensers – do not meet ADA mounting heights

The building and fixtures do not comply with current energy standards. To remedy these deficiencies, the building would need to be enlarged. Modifying the existing structure and access routes to comply with current codes would be more expensive than demolition and replacement. That fact, coupled with the age of the restroom itself, makes remodeling the restroom untenable.
