**Saltwater State Park - Context Plan**  
Washington State Parks Sound-Friendly Vision Plan

January 2007

SITE ANALYSIS MAP FOR TECHNICAL WORKSHOP

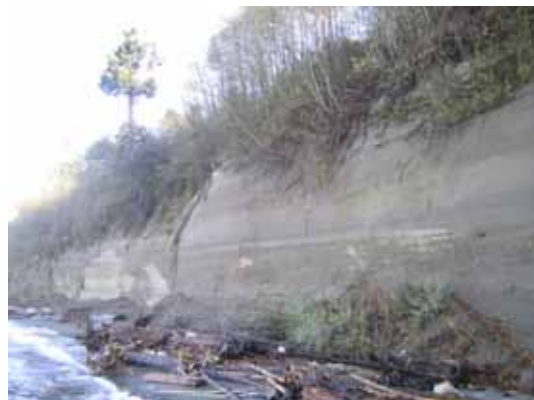
Example of Feeder Bluff Contributing Sediments to Puget Sound

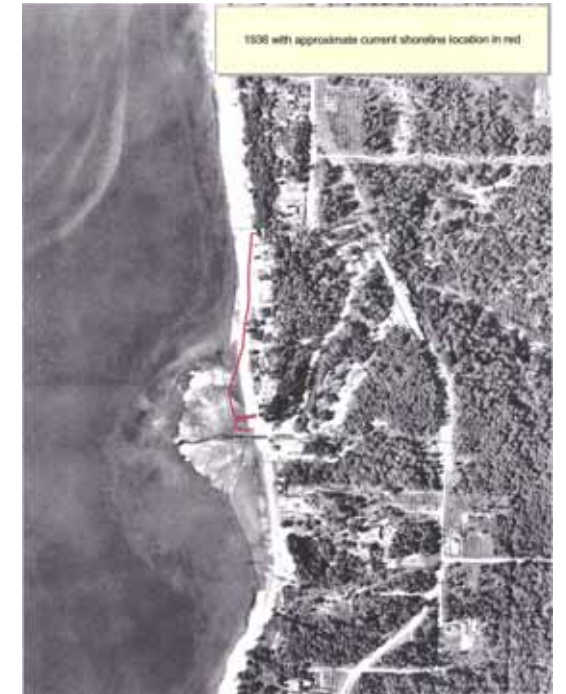
1936 Aerial Photo and current shoreline configuration (red line). Note that McSorley Creek historically enters Puget Sound further south and shoreline has been filled to extend shoreline waterward from historic configuration.

*Shoreline armoring at mouth of McSorley Creek and along Puget Sound shoreline. See 1936 photo above left for comparison to historic shoreline location.*

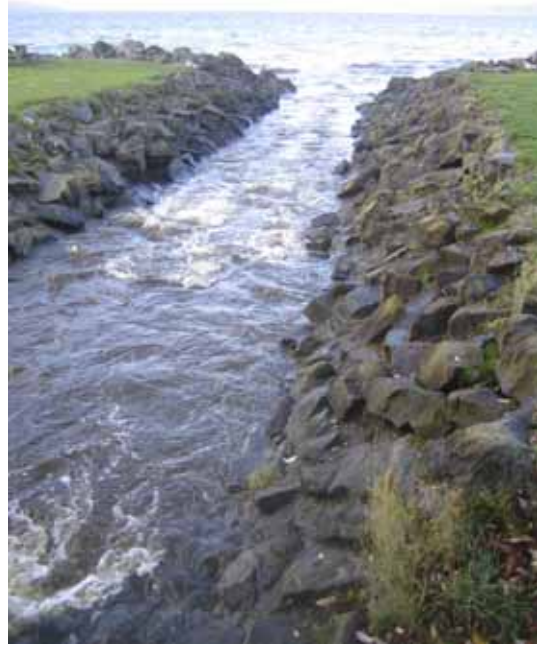
*Straightened channel at mouth of McSorley Creek*

The mouth of McSorley Creek is straightened and narrowed by a steep riprap revetment that extends into the intertidal zone of Puget Sound. These riprap walls severely impair the habitat function of the creek mouth. The constriction causes higher water velocities, particularly during high flow events that can sweep juvenile salmonids out of the creek prematurely. The narrow mouth also prevents flows from dispersing across multiple small channels that provided a larger mixing zone area for the transition from freshwater to saltwater. The armored creek mouth also provides no habitat for an estuarine marsh. In a natural setting, McSorley Creek would support a broad estuarine marsh on either side.

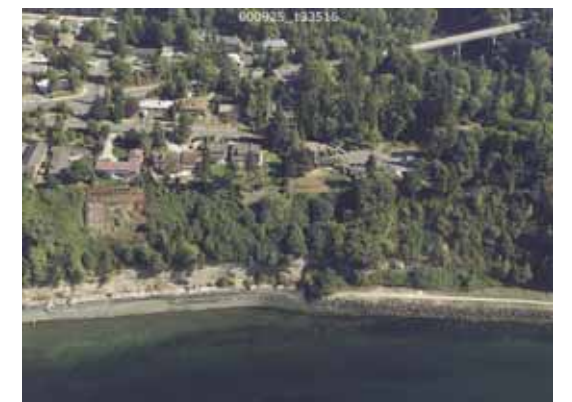
*View of disconnected feeder bluff in park (right) and connected feeder bluff adjacent to park (left)*

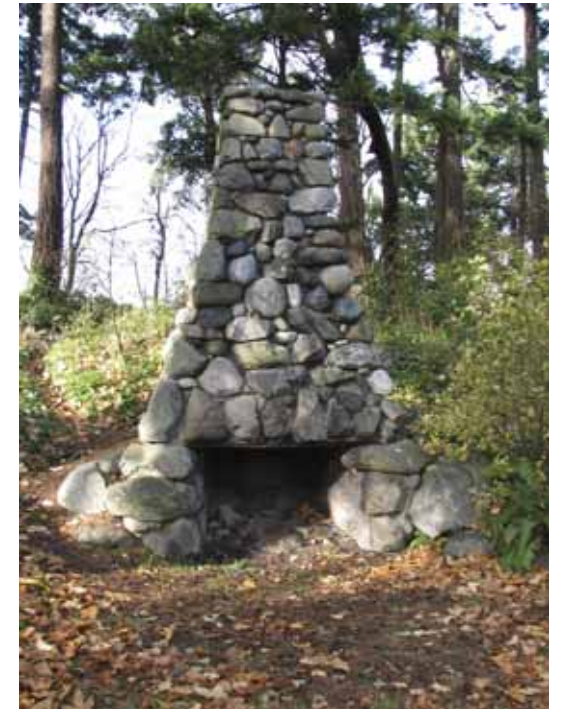
*Fire pit*

The most historically significant structures are the park office and ranger housing buildings near the entry. Constructed with indigenous stone bases and logs, they are relatively intact and provide an opportunity to educate the public about the massive work effort of the CCC. Though generally well-maintained, they do reveal a variety of non-historic, utilitarian interventions and additions, including shed attachments, wall infills, and window replacements and interior renovations. The stonework of the era is also evidenced in the outdoor chimney at the group campfire area. Although the iron lintel exhibits distress, the structure is otherwise in good condition.

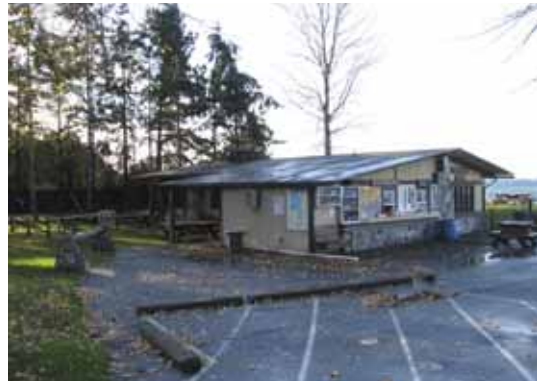
Concessions building

The concessions building at the beach is of more recent construction. Its stone hearths may contribute to the park's historical significance, but its wood frame construction has been altered over time and is of less value. The structure is in a depressed area within the creek's flood plain and is subject to flooding due to tidal and/or stormwater events that periodically overwhelm the drainage system. The post-and-beam picnic shelters are Depression-era in style only; dating from the 1970s, these structures are not historically significant.

The concession building and adjacent paved picnic area is in a low area and floods during high tides. The building appears to be at or below the level of the adjacent beach backshore. It is separated from the beach by a 2–3-foot-high grass covered berm. Water backs up behind this berm and comes out of catch basin grates during high tides, according to State Parks staff. The building and adjacent low areas are at long-term risk from predicted sea level rise associated with climate change. The sea level rise predicted for the Central Puget Sound between Seattle and Tacoma is approximately one meter by the year 2100 (Puget Sound Action Team, 2005).

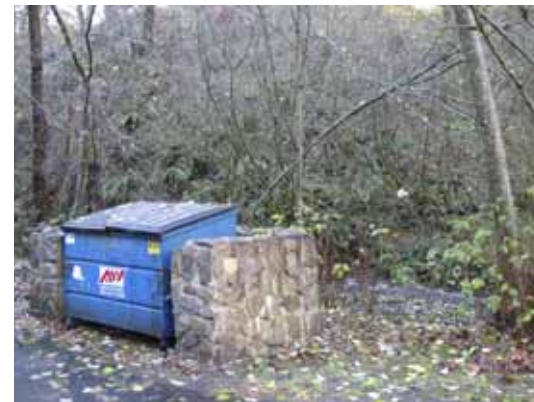
*Dumpsters in campground at creek edge*
